National Bulk Tanker Day

Industry Safety Forum

Roger Weeks, Director Compliance
Roads & Maritime Services

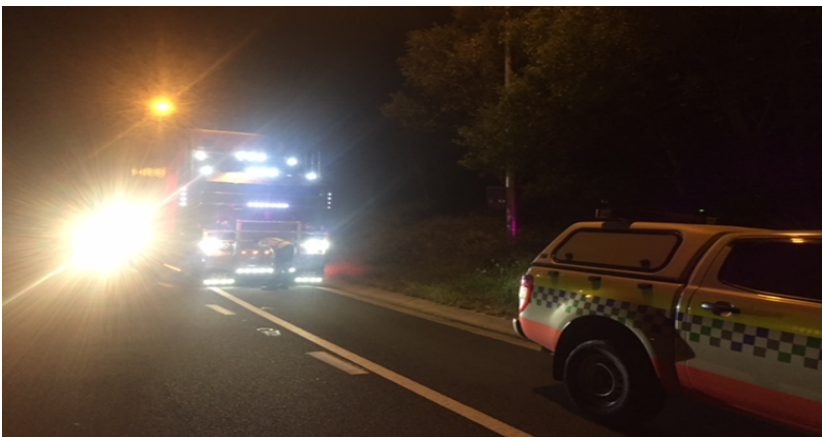
17 April 2018, 1930HRS, Yelgun Interchange, Pacific Highway (southbound)

ECM speed limiter = 141.3kph

Driver positive RDT (methamphetamine)

Cab search = radar detector, drugs

Major grounded defects:

- ECM
- Driver's seatbelt inoperative
- Passenger seat not bolted down
- Cracked windscreen
- Brakes – both trailers, all push rods travel more than 80%
- B-double over length by 1.39m

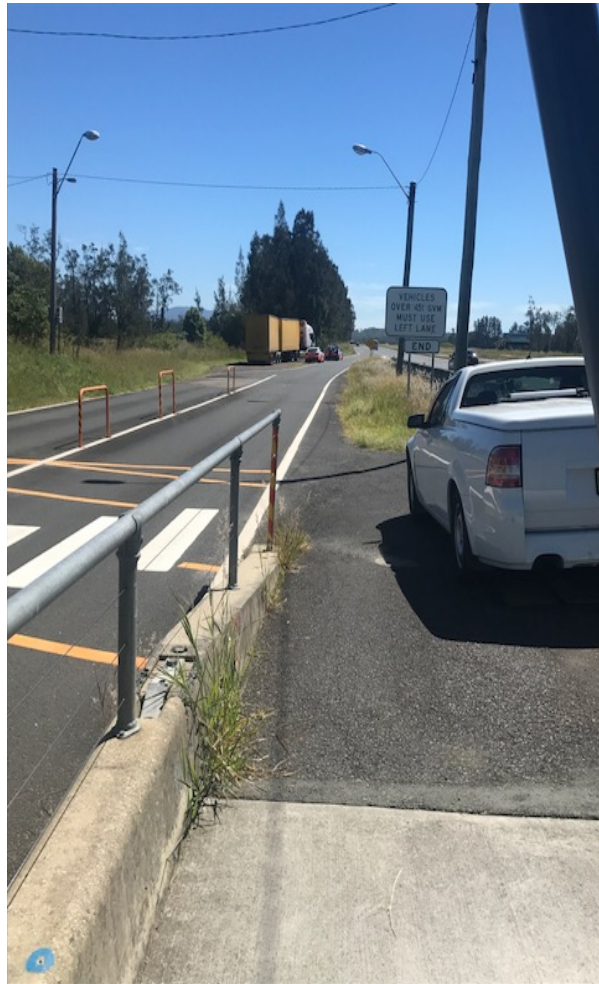
19 January 2018, 0834HRS, Jones Island HVIB

Critical fatigue breach: Driver direction = 7 hours rest

- Driver appeared dazed, eyes glassy, mumbling, drooping
- over steering wheel, slow reaction times
- Reported 'near-miss' on M1 at Mooney Mooney
- Attended to by Ambulance at Beresfield
- Minimal/poor sleep, disrupted by multiple calls from manager
- 6th day of driving
- No work diary entries
- Admitted to false and misleading entries
- Police called – negative RBT/RDT
- Escorted to motel for 7 hours rest period

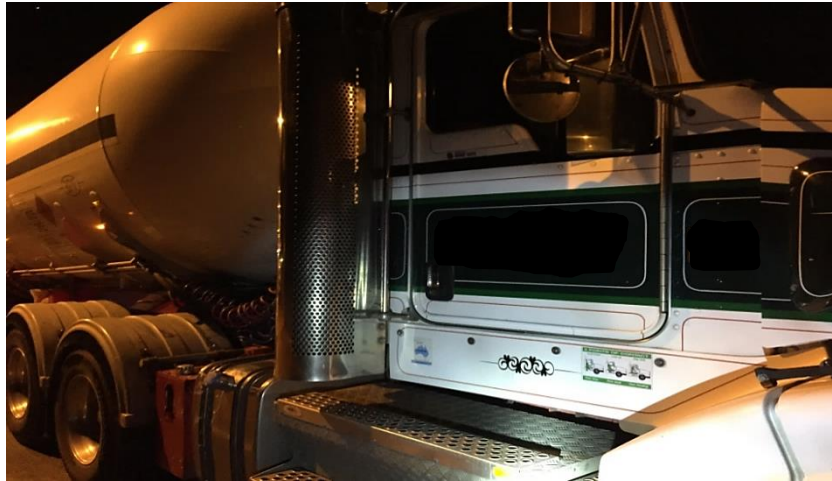
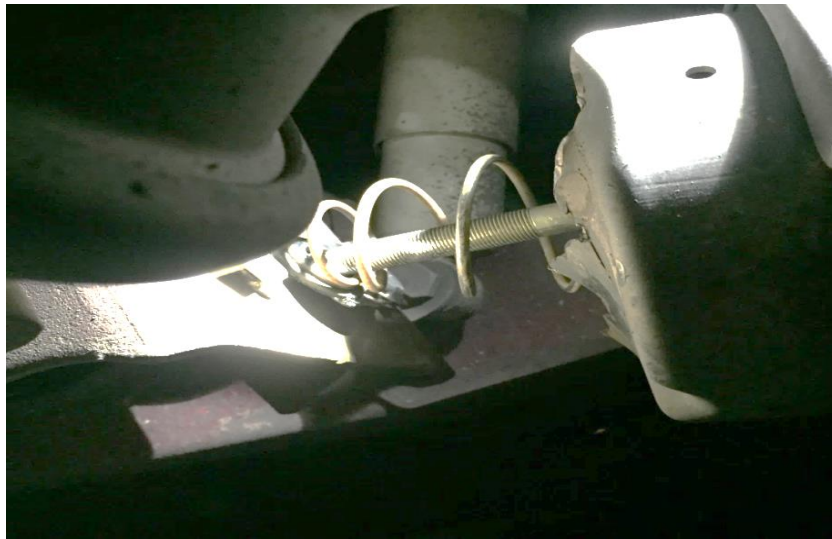
30 July 2018, Chinderah NSW

Major Defect Notices Issued - defective brakes

- Vehicle inspection found defective brakes on both “A” and “B” trailers
- “A” trailer: broken brake chamber, only attached to the trailer by pushrod rendering it inoperative. Rust detected on friction surface.
- “B” trailer: damaged and bent pushrod on one brake chamber
- “B” trailer: stroke indicator exposed with excess travel on another brake pushrod
